Inspection Report

Property Address:
1234 Minor Street
Fairfax County Virginia 22153

Date: 3/29/2017	Time: 01:30 PM	Report ID: 170322
Property: 1234 Minor Street Fairfax County Virginia 22153	Customer: Jane Doe	Real Estate Professional:

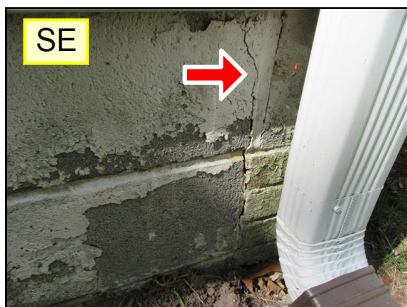
1.0 It is my opinion the vertical cracks in the foundation wall at the front, rear and sides of home do not appear significant to require repairs at this time. A qualified person should seal the cracks to prevent damage from water intrusion and insects.

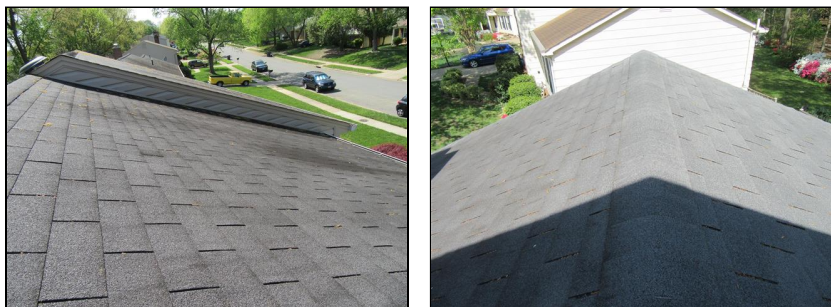
2.0 (1) Although the shingles covering the roof of this home showed deterioration, they appeared to be adequately protecting the underlying home structure at the time of the inspection. Note - roof shingles were discolored due to algae growth from nearby vegetation, shade and moisture. The color difference is only cosmetic, and does not effect the integrity of roof covering. Algae is difficult to remove without damaging the shingles; do not power wash as it could cause loss of granules.

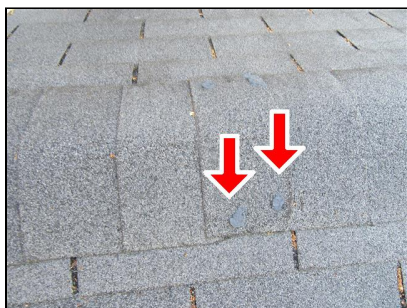
2.0 (2) Observed exposed nails in ridge roofing material. Each exposed nail has the potential to leak and rust. Recommend a qualified person or roofing contractor caulk and repair as necessary on a routine basis to maintain integrity of the seal.

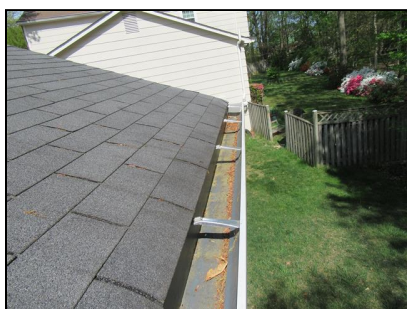
2.2 (1) The gutters and downspouts should have all the debris removed by a qualified person in order for the water to flow properly and not create ice dams in the winter. The debris in gutters can also conceal rust, deterioration or leaks that are not visible until cleaned. Am unable to determine if such conditions exist.

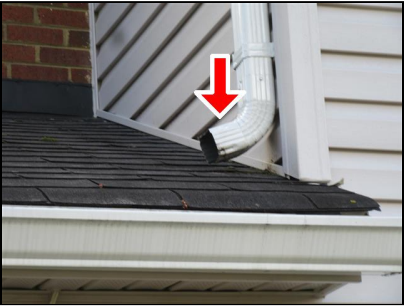
2.2 (2) Gutters and drain lines are needed on several roof section or erosion of shingles could shorten there life along the discharge path. Recommend a qualified person install extenders or gutter section along these short roof lengths.

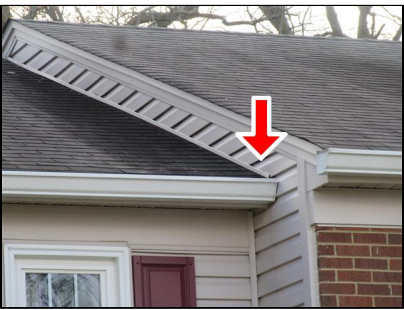
2.3 Kick-out flashing, which directs the water from the sidewall into the gutter system or away from the wall, was missing. Missing this type of flashing can lead to moisture intrusion of the wall structure below this area. Hidden damage may exist. There was some evidence of moisture intrusion in the trim below. Recommend a qualified contractor evaluate and install as necessary.

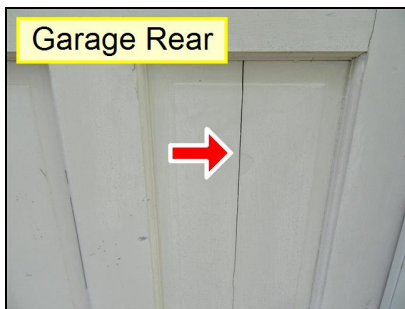
3.1 The garage entry door was cracked/damaged as indicated. This is a maintenance issue and is for your information. .

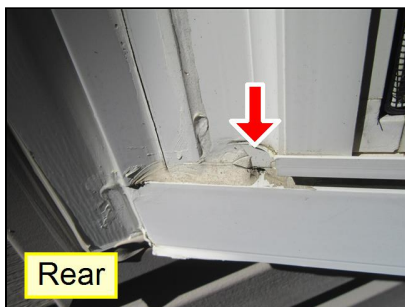
3.2 Recommend all windows be sealed/caulked by a qualified person outside and inside to prevent air loss as part of a normal maintenance program to properly maintain the home. Observed an opening at the rear left kitchen window that needs to be sealed.

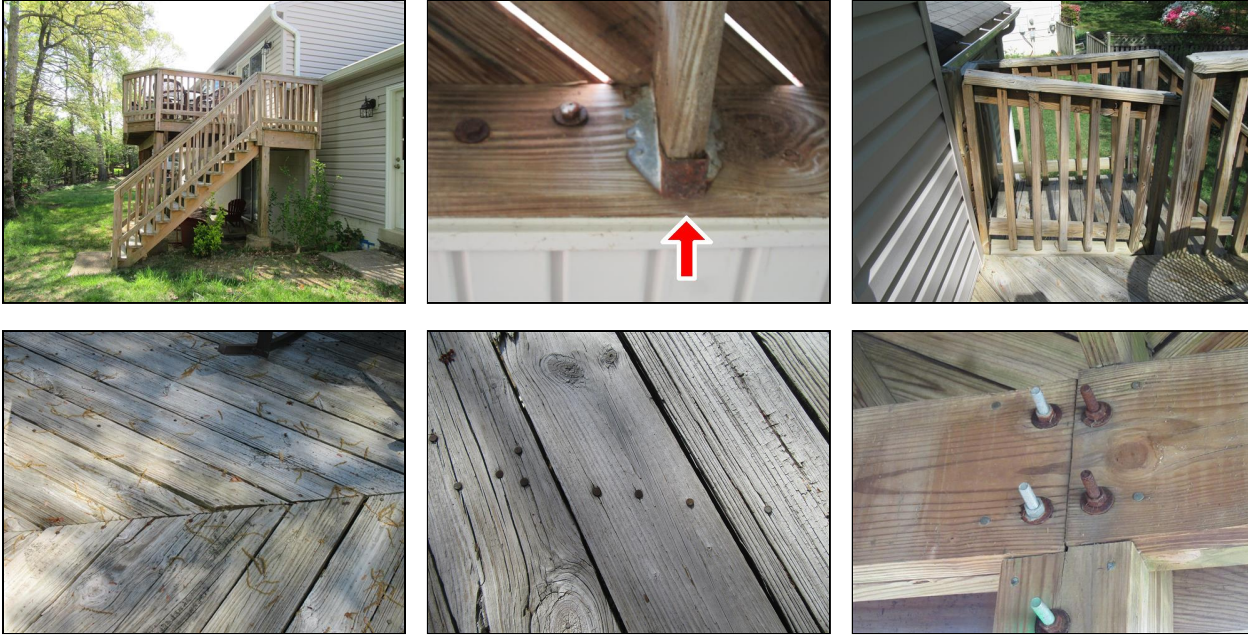
3.3 (1) The rear wood deck and stairs were aged, deteriorated and contained multiple problems such as one rusted joist hanger (Photo 2), partially detached swing gate (Photo 3), several loose floor board ends (Photo 4), rusted attachments (Photos 5&6), etc. Recommend a deck specialist further inspect and repair/replace as needed. A general replacement of the floor decking members is likely.

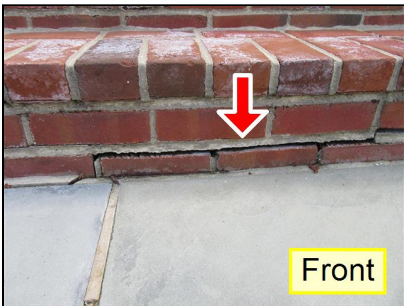
3.3 (2) The front entry bottom riser has what appears to be a settlement crack with an open joint. The crack does not appear in my professional opinion to have an impact on the overall structural integrity. Recommend the open joint be sealed by a qualified person to minimize water intrusion.

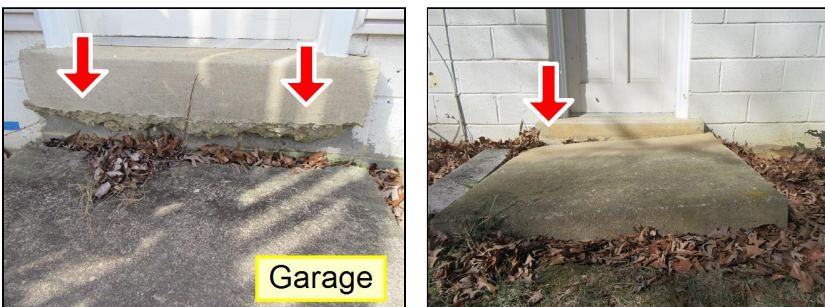
3.3 (3) The rear entry slabs at the garage and utility room have separated from the exterior wall, each several inches (see Photos). Both slabs will require replacement by a qualified contractor to provide safe egress.

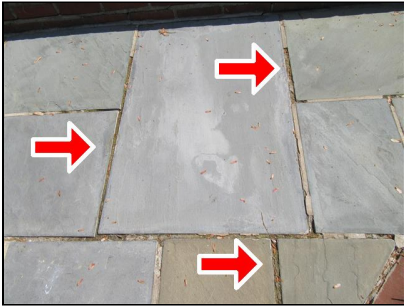
3.5 (1) The stone paver walkway at the front of home was deteriorated and missing grout in isolated locations. Water can cause further deterioration if not repaired and sealed properly. A qualified contractor or person should seal/repair as needed and maintain seal on a regular basis.

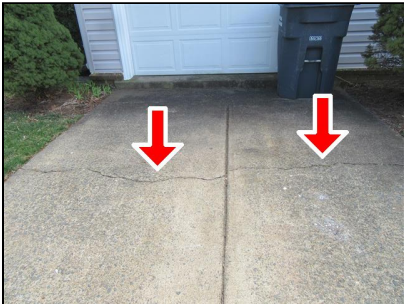
3.5 (2) The concrete driveway at the front of home had cracked and settled toward the exterior wall of the garage and thus created a negative slope allowing water to drain toward the foundation wall. Water can cause further deterioration if not drained properly. A drainage slope away from the home is needed. The settlement crack should be sealed. A licensed contractor should seal/slope/repair/replace as needed and maintain seal along home on a regular basis.

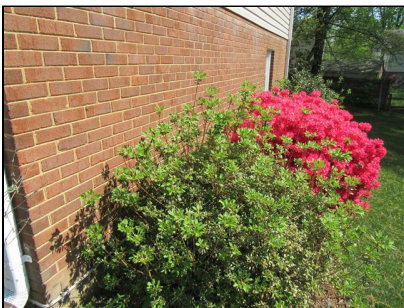
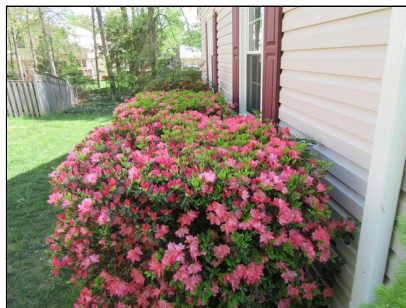
3.6 (1) A recommended distance of 2 feet between any bushes/shrubbery and the home should be maintained. This distance allows for proper air circulation into the foundation vents and helps deter attracting insects near the home. Recommend a qualified person trim or replant existing shrubbery too close to home.

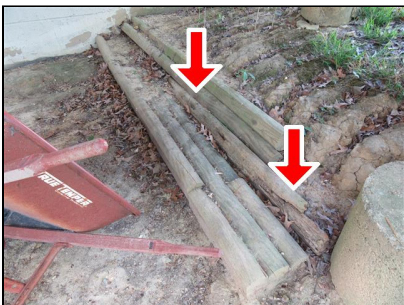
3.6 (2) The rear timber retaining wall was in fair condition. One member was deteriorated and may need to be replaced in the future by a qualified person.

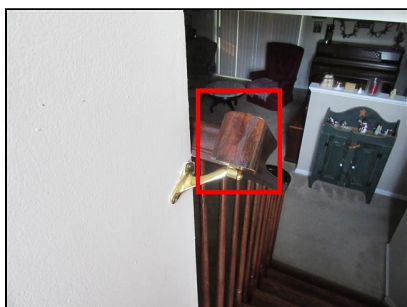
4.3 Handrail ends were open and did not return to the wall or terminate at newel posts or safety terminals. This is a safety issue as clothing could catch and cause a fall or injury if not corrected. A qualified contractor should repair or replace as needed.

Handrail ends were open and did not return to the wall or terminate at newel posts or safety terminals. This is a safety issue as clothing could catch and cause a fall or injury if not corrected. A qualified contractor should repair or replace as needed.

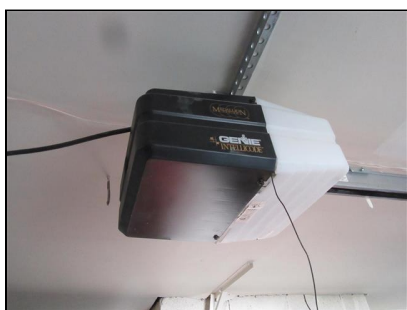
4.7 (1) The auto reverse mechanism on the vehicle door opener appeared to need an adjustment. This is a safety hazard, especially for small children and pets. Recommend a qualified person adjust the mechanism so the garage door properly reverses.

(1) The auto reverse mechanism on the vehicle door opener appeared to need an adjustment. This is a safety hazard, especially for small children and pets. Recommend a qualified person adjust the mechanism so the garage door properly reverses.

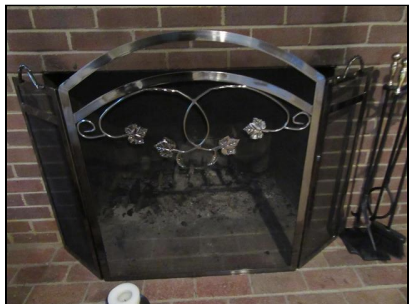
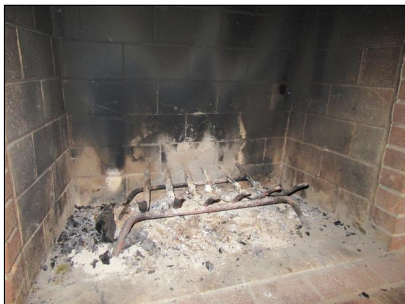
4.10 (1) The firebox contained ashes and cobwebs, somewhat blocking access to observe actual surfaces. Recommend a certified chimney sweep clean and inspect before using the fireplace.

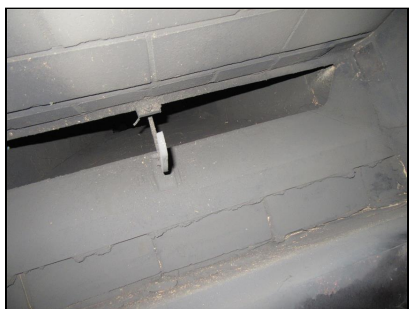
4.10 (2) The liner was partially visible and appeared good, but due to creosote build-up I could not inspect for cracks. Recommend a certified chimney sweep further inspect.

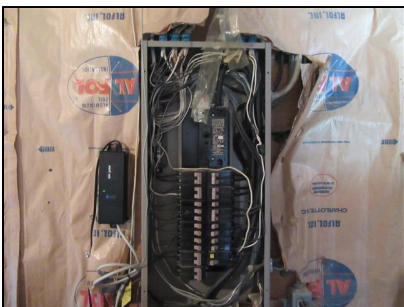
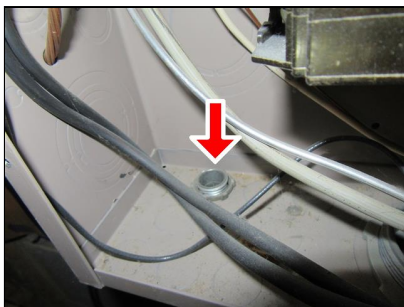
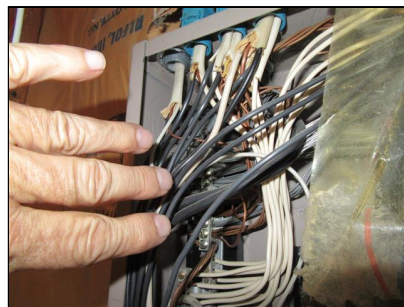
6.4 The problems discovered in the panel such as opening at bottom (Photo 2 - panel is a fire rated box), triple grounds under one lug (Photo 3) and any other problems that a licensed electrician may discover while performing repairs need correcting. Recommend a licensed electrical contractor inspect further and correct as needed.

The problems discovered in the panel such as opening at bottom (Photo 2 - panel is a fire rated box), triple grounds under one lug (Photo 3) and any other problems that a licensed electrician may discover while performing repairs need correcting. Recommend a licensed electrical contractor inspect further and correct as needed.

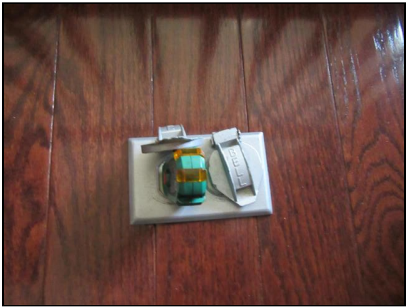
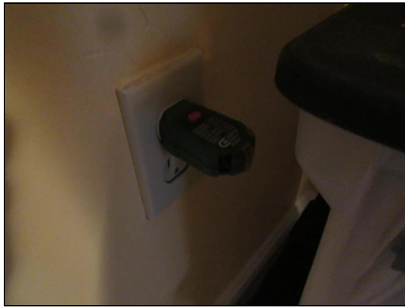
6.7 (2) At least two "three-prong" outlets were not working in the living room (Photo 1) and in the lower right bedroom (Photo 2). Electrical issues are considered a hazard until repaired. A qualified licensed electrical contractor should perform repairs that involve wiring.

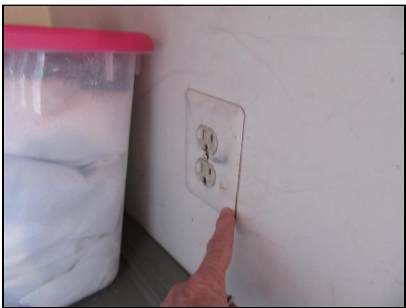
6.7 (3) One loose receptacle was observed in the garage. Loose receptacles can cause fatigue of the wires over time. Recommend a qualified licensed electrician tighten or replace the receptacles as necessary. Further evaluation of any receptacles that was obstructed by the belongings and storage items should be performed.

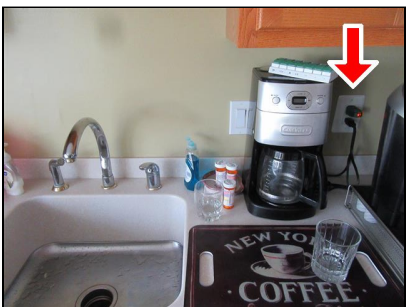
6.8 (1) The kitchen outlets near the sink was not a "three-prong" GFCI outlet. Electrical issues are considered a hazard until repaired. Recommend a licensed licensed electrician upgrade for safety purposes.

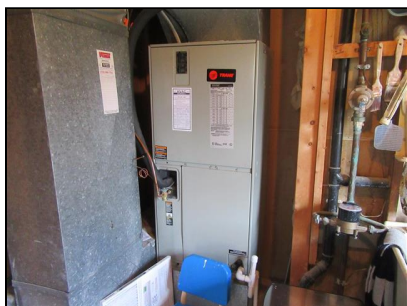
7.0 The furnace was aged but did work during the inspection. Am unable to determine life remaining.

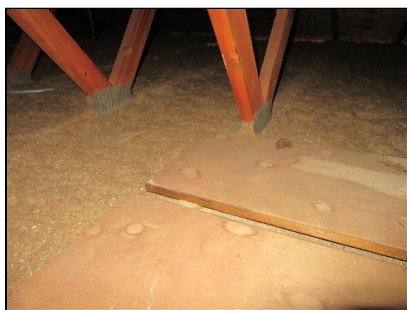
9.0 Cellulose insulation was about six inches thick or just under 22 R Value.

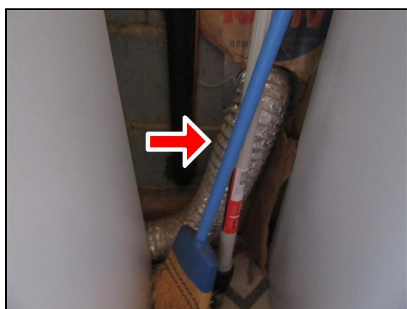
9.5 (2) Dryer vent consisted of mylar foil tubing, which is not approved for use as a clothes dryer vent material. It should only be used as the transition duct between dryer and rigid dryer vent. Transition duct should be short as possible; must not run within a wall, floor or ceiling covering since it can not be easily inspected and cleaned. Its ribbed interior surface tends to allow for lint to easily accumulate, which is a potential fire hazard. Recommend a qualified person replace with a rigid and flexible metal that has a smooth interior surface and not have sheet metal screws extend into the vent.
